Limited Visual Dam Safety Inspection Summary Report

MA-081

Reservoir 61

Limited Visual Dam Safety Inspection Conducted on: 03 April 2006

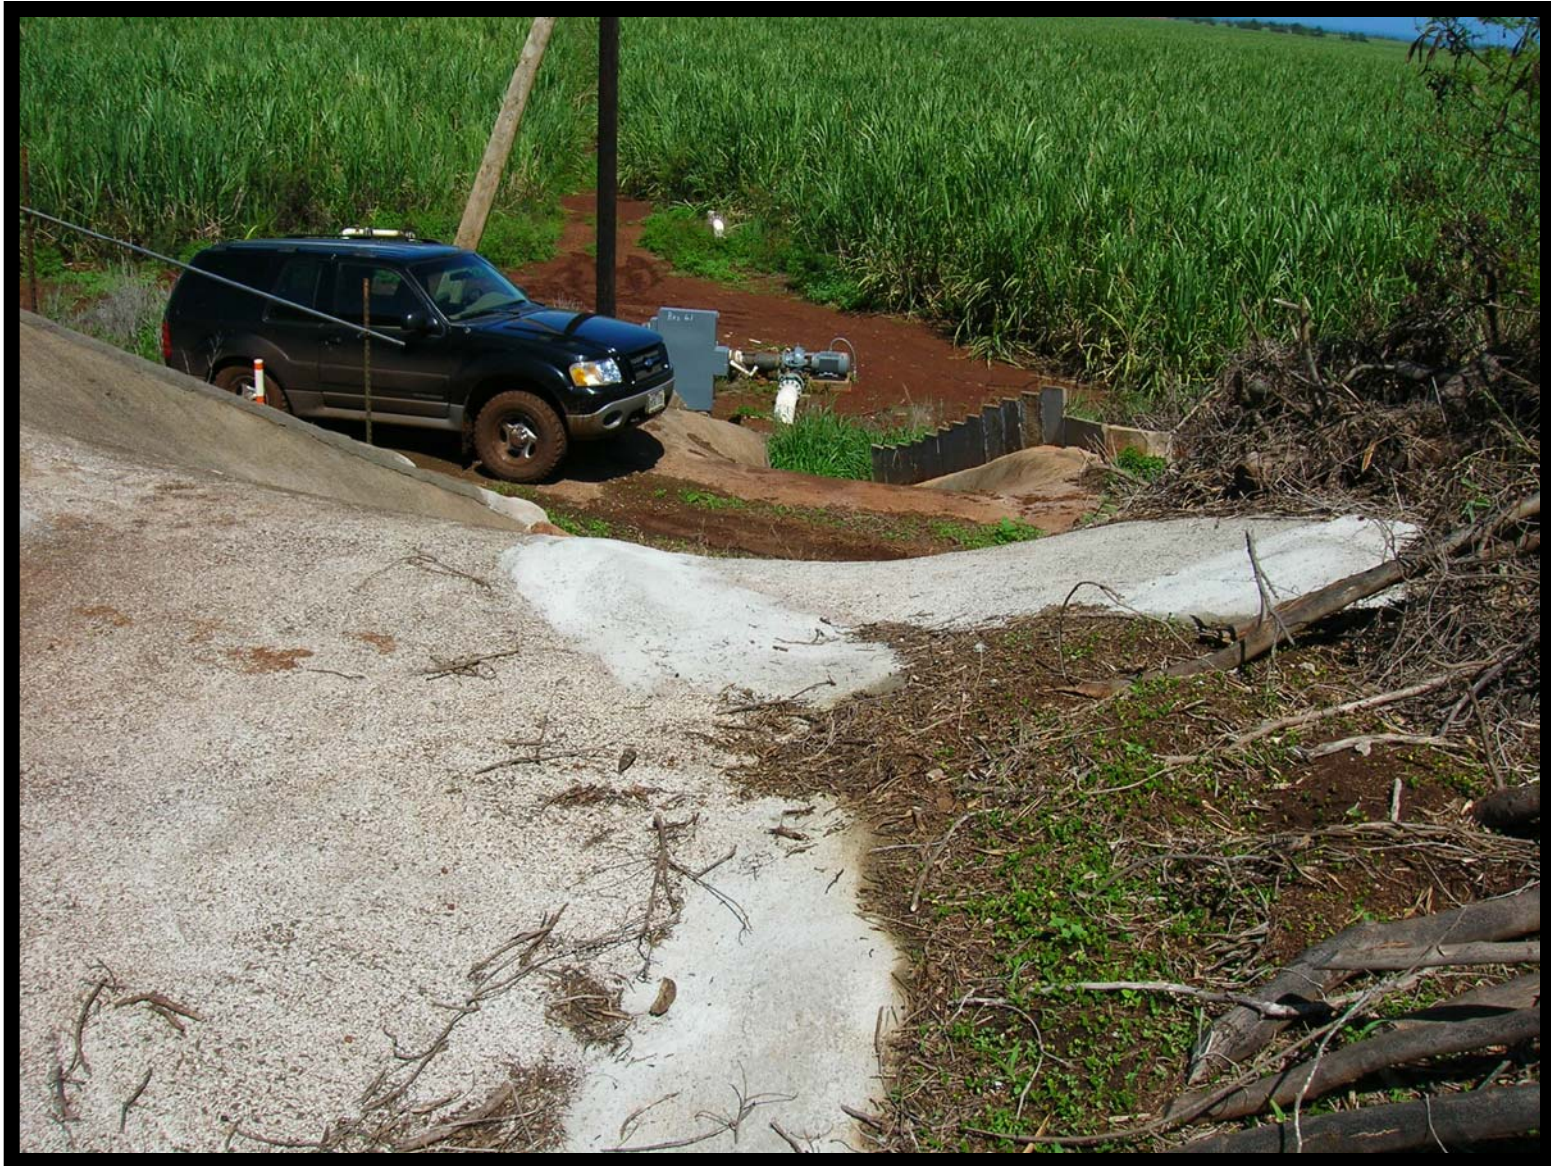
081 View of the spillway exit channel.

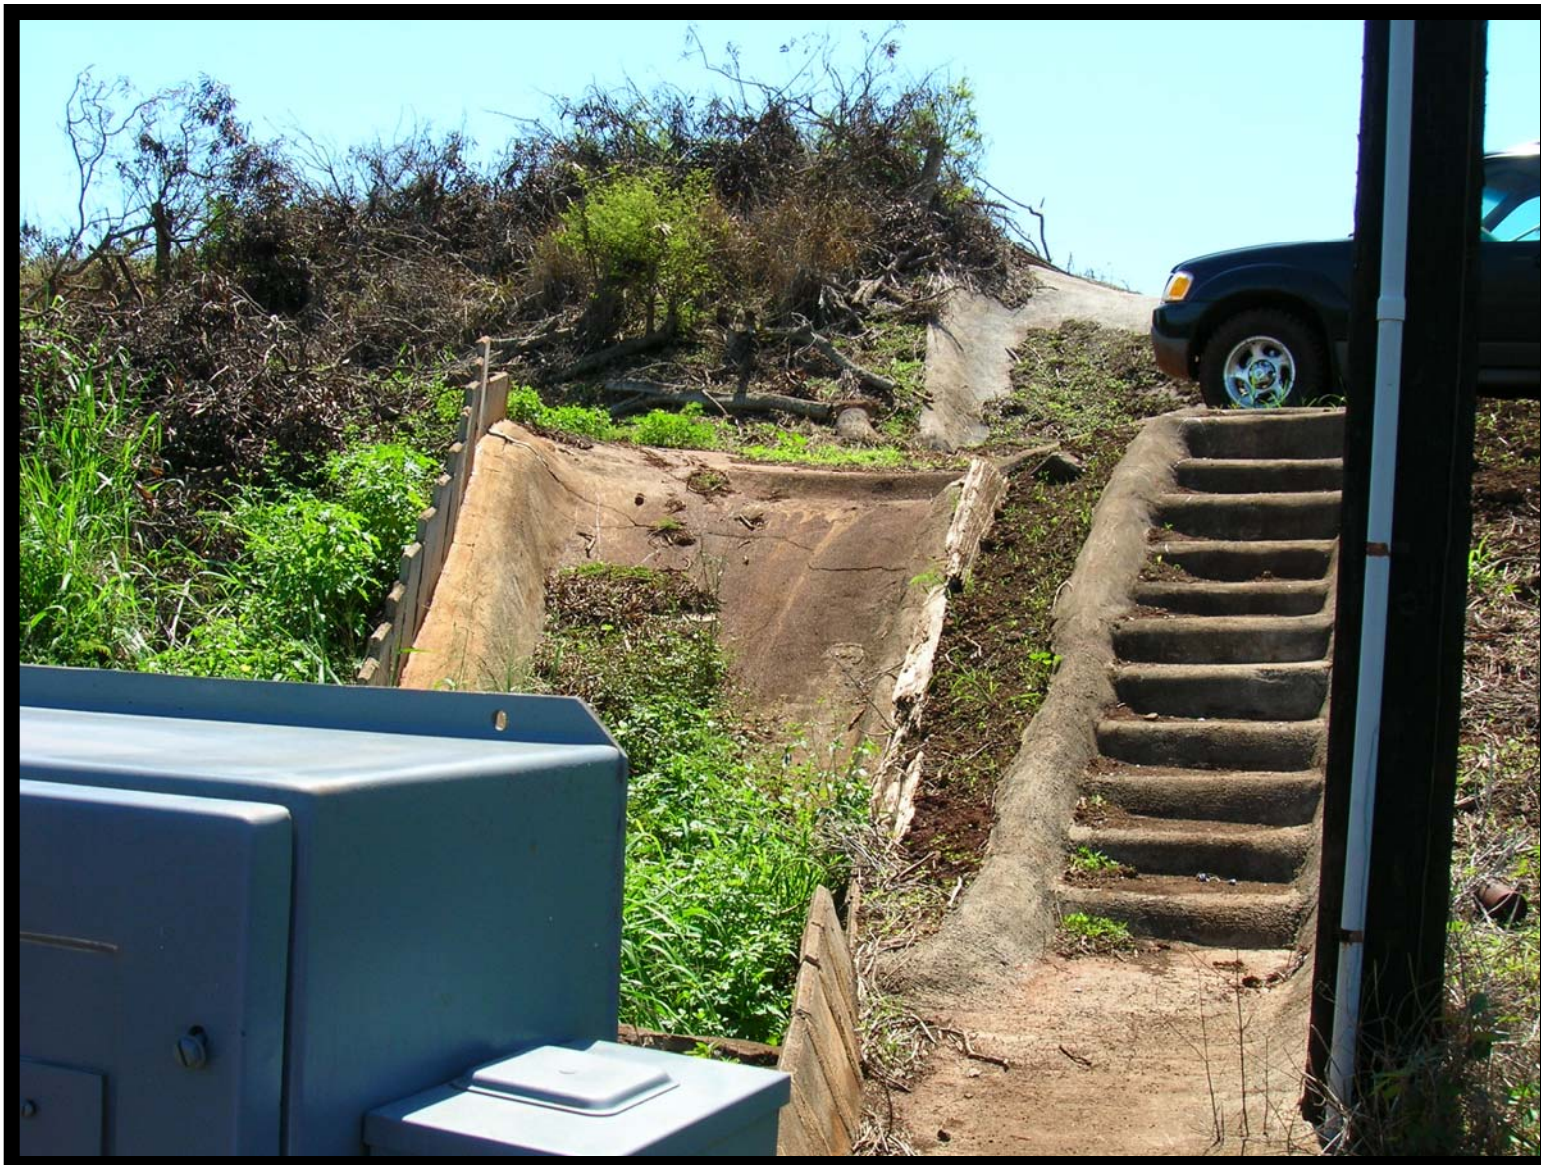
081 View of the spillway exit channel and stairs that lead from crest to outlet works.

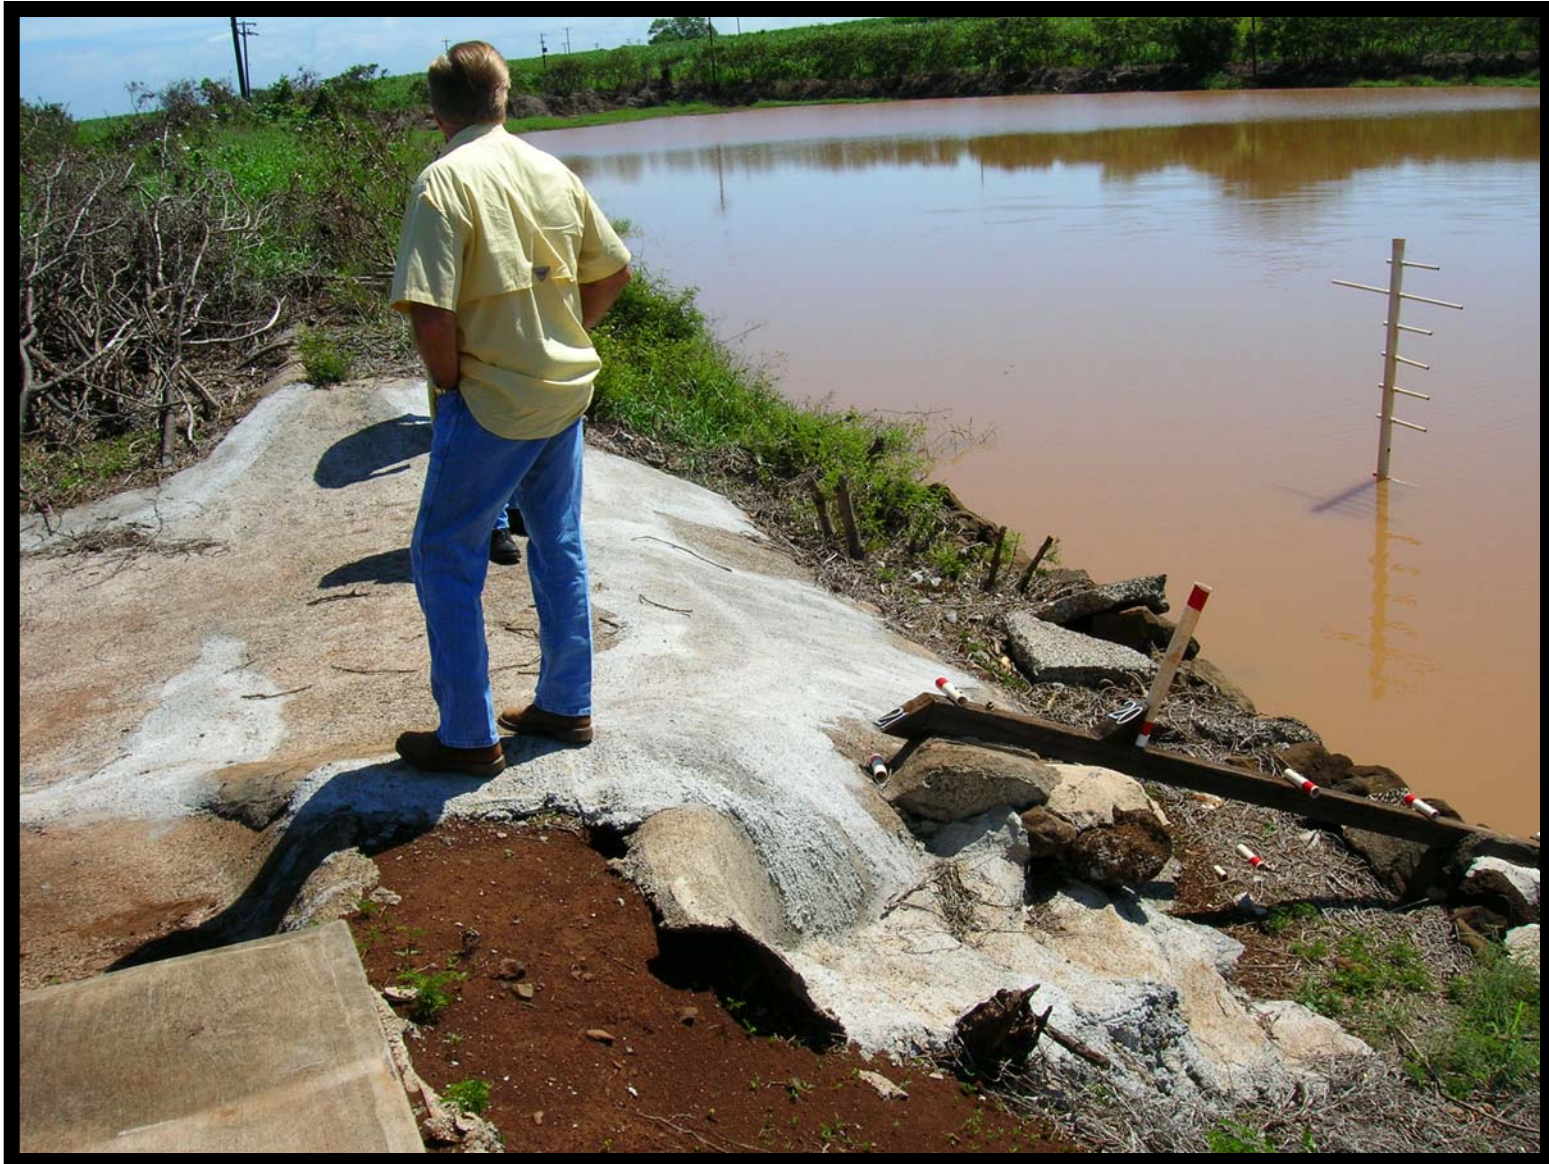
- a. The Spillway appeared to be in satisfactory condition, no corrective actions are required at this time.

081 View of the spillway and spillway approach.

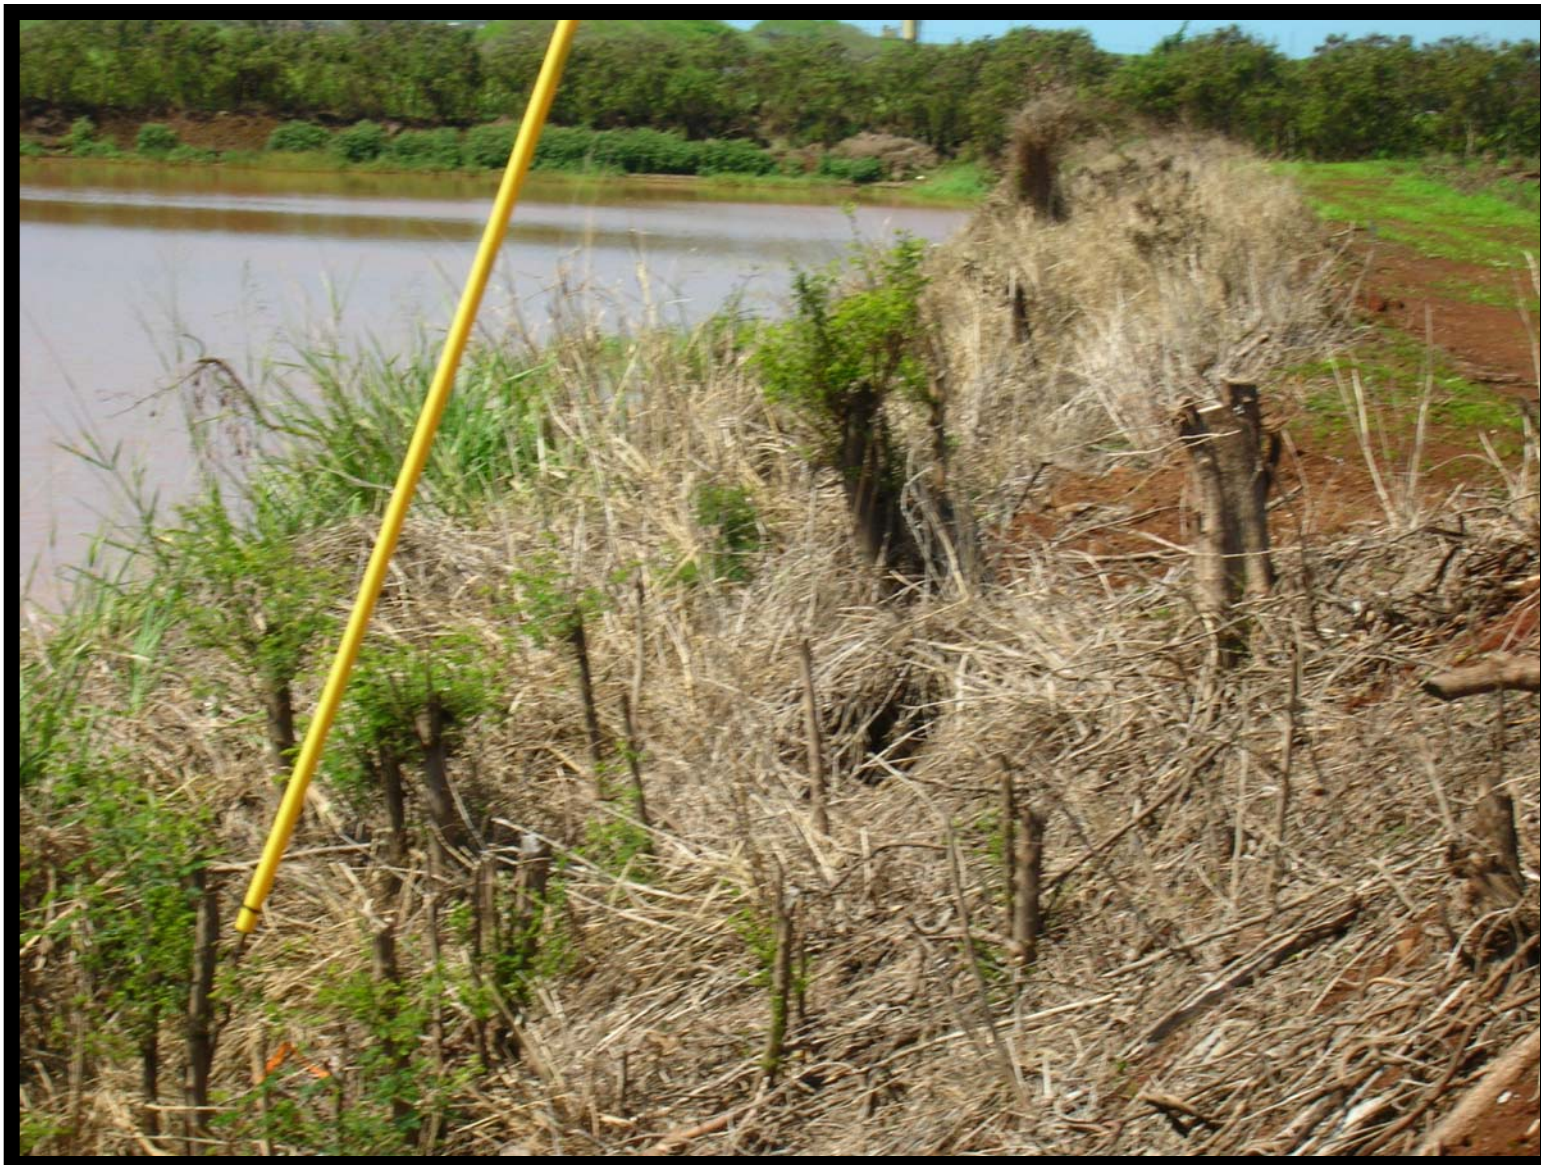
- a. The upstream slope appeared to be in fair to poor condition and requires corrective action.
- b. The upstream slope was not visible due to high grass and bush vegetation. Clear high vegetation and maintain low to enable easy visual inspection.

081 View of the upstream slope. Note the cut brush.

LONG TERM RECOMMENDATION: The upstream and downstream slopes of the embankment should be clear and visible for inspection. Underbrush should be cleared and grasses kept short. The dam owner routinely removes vegetation and trees from the slopes. The owner should continue with the routine removal of vegetation. At one location, recently cut trees and brush were left on the downstream slope. All cut vegetation debris should be removed off the embankments and disposed of offsite.
